Seismic Hazard of an Area near San Rafael del Sur, Western Nicaragua

ABSTRACT OF THE STUDY

Title: Seismic Hazard of an Area near San Rafael del Sur, Western Nicaragua

Place y year presentation: Managua, Nicaragua, 2006

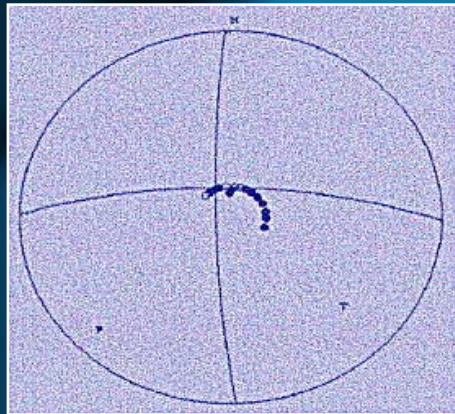
ML = 3.5; h = 0.1km; 05:24Hrs
(271°, 72°, 9°); Rumbe side
left. (I)

A.2. Geometry space rupture for local quake occurred in years 2000 - 2002 based on historical records and styles of movement

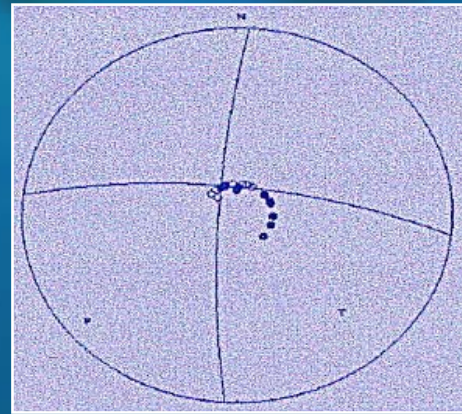
ML = 3.3; h = 0.0km; 05:24Hrs
(277°, 73°, 10°); Rumbe side
left. (II)

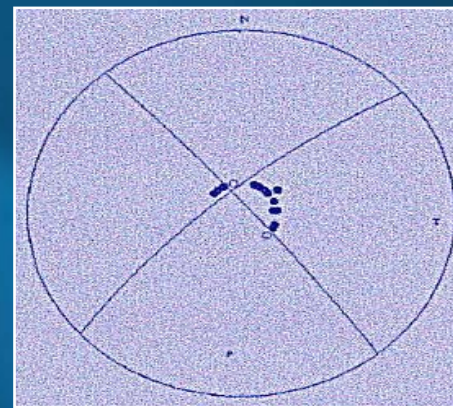
ML = 2.5; h = 1.1km; 05:20Hrs
(229°, 76°, -5°); Rumbe side
left (VI)

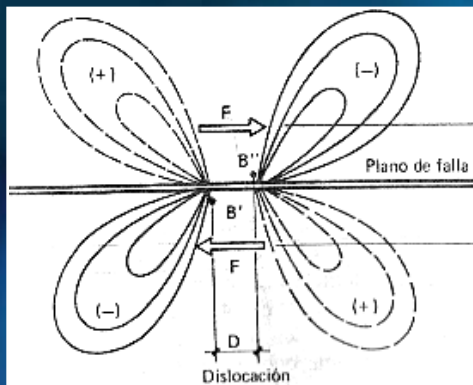
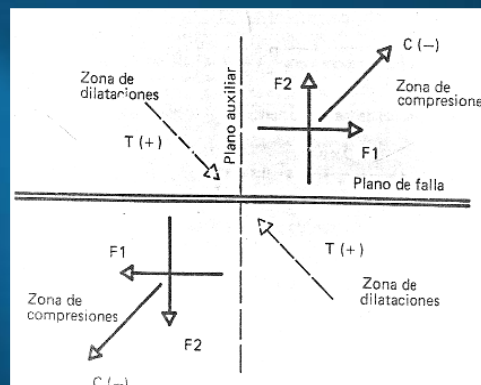
A.2.2 Graphic. a) Par Force F produces areas of compression and expansion. b) Equivalence between a pair of double forces and two dipoles perpendicular to 45° with the plane crashes: one of compression and expansion of another. c) Effort shear acting on both sides of the fault occurring on deformation and displacement.

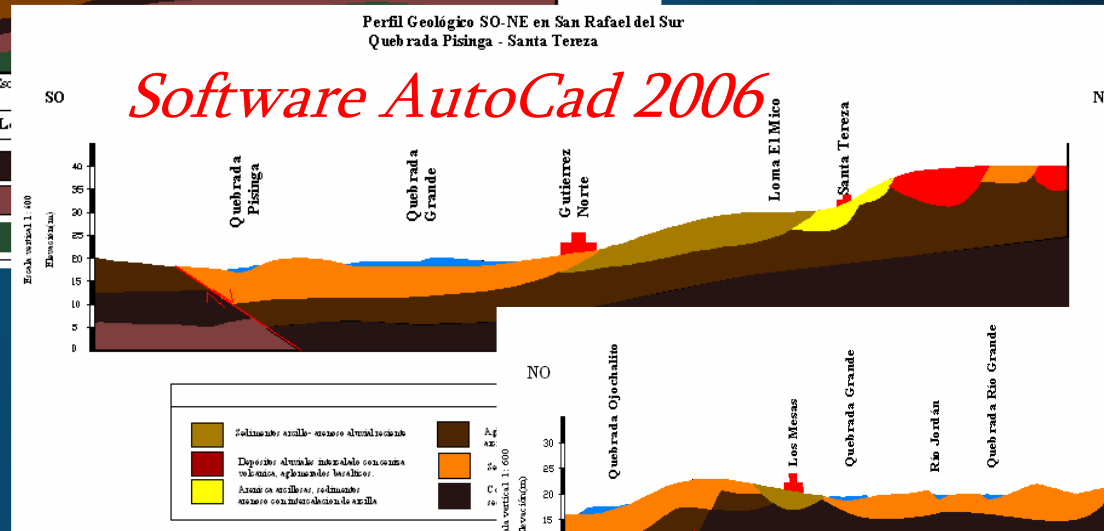
Quebrada Pisinga-Santa Teresa en direction Northeast - Southwest

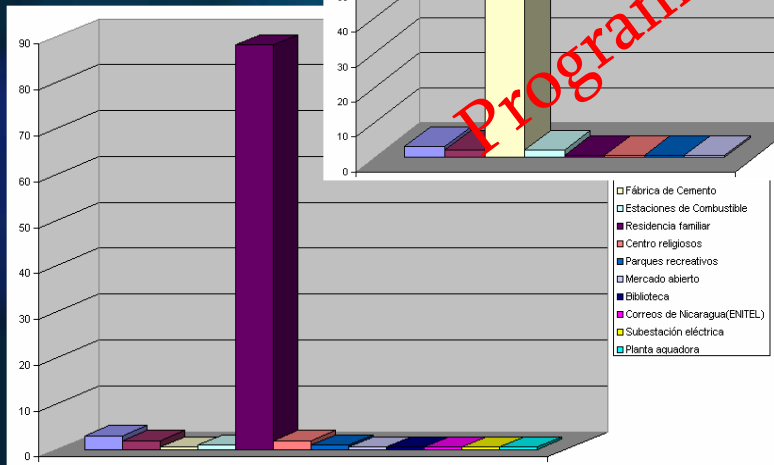
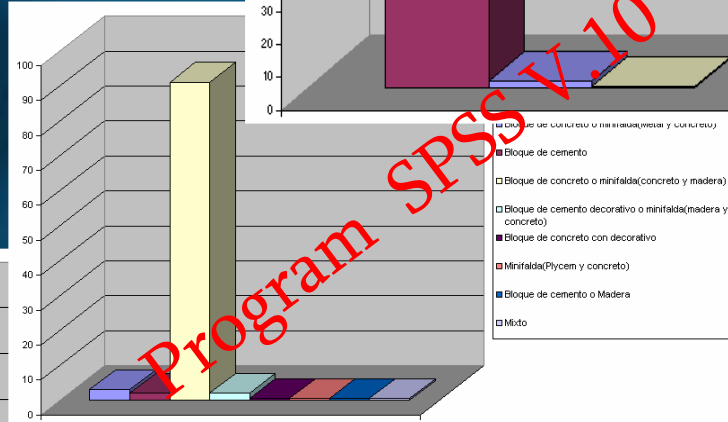
F) STATISTICS OF PHYSICAL INFRASTRUCTURE STUDY SITE

4) In 90% the physical structures are traditional brick floor

3) The 97% of the local construction are characterized by using zinc roof

2) The 91% of the wall or parapet that are formed with local houses are in masonry

1) Predominance of family residences, with a representative percentage of 88%
